RAILROAD ACCIDENT REPORT

VINYL CHLORIDE MONOMER
RELEASE FROM A
RAILROAD TANK CAR AND FIRE
FORMOSA PLASTICS CORPORATION PLANT
BATON ROUGE, LOUISIANA
JULY 30, 1983

NTSB/RAR-85/08

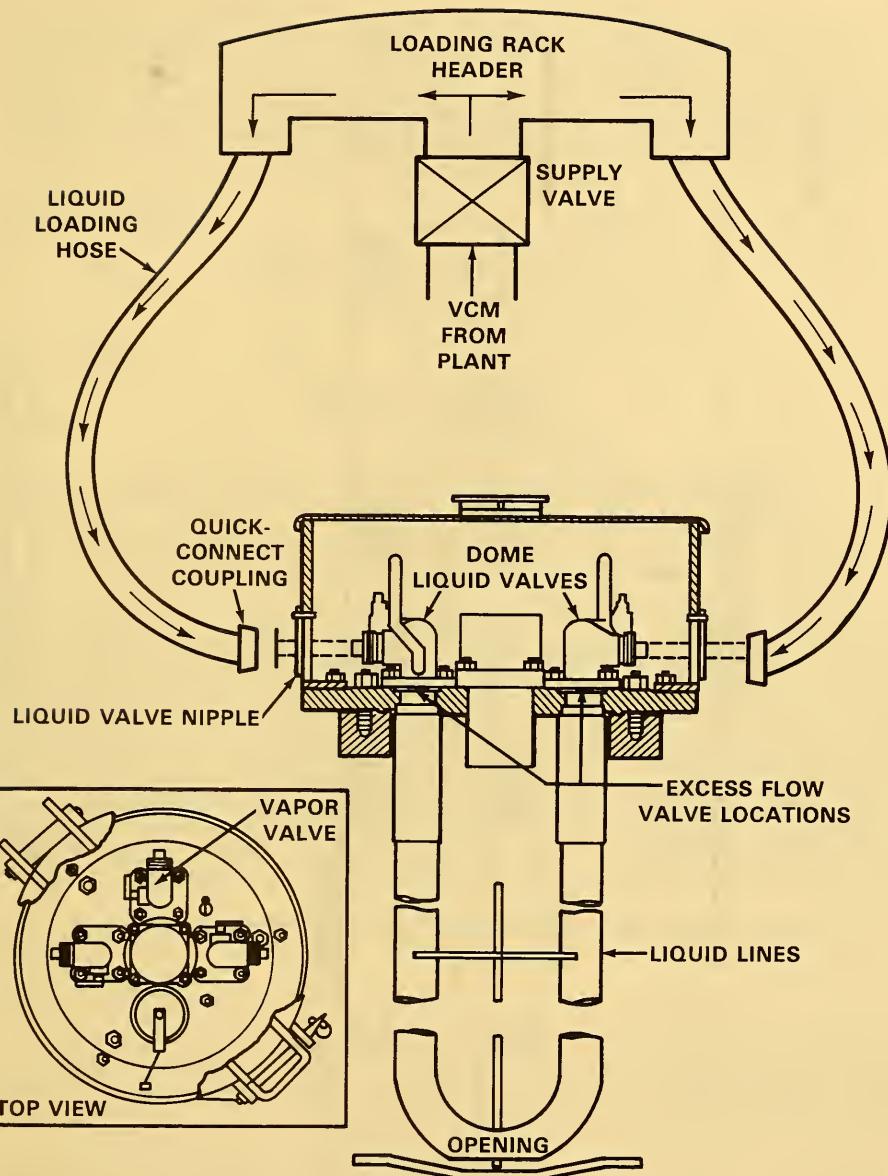
Figure 1.—Side view of tank car with liquid loading hoses attached for loading, and top view (inset) of tank car shown without manway bonnet cover.

Following the accident, investigators found that the safety valve 4/ (see figure 1) on the tank car at station No. 6-2 did not activate during the fire. Loader-1 had laid the seal used to secure the manway bonnet cover on top of the safety valve before the accident, and the seal was not blown away as it would have been if the safety valve had released. Investigators also found that the liquid loading and vapor hoses had been removed from the tank cars at station Nos. 5-1 and 6-1 and that all of the valves and manway covers on these tank cars had been closed before the accident.

Both tank cars had two internal liquid lines through which chemicals could be loaded. The liquid lines extended into the tank from the manway entrance at the car dome. (See figure 1.) Each liquid line was fitted at the manway entrance with a 2-inch-diameter, ball-type, steel-body angle valve containing a stainless steel ball. Directly under each liquid valve was a 3-inch-diameter excess flow valve. Each tank car also contained a vapor line through which chemical vapors could be vented during loading. The vapor line extended into the tank from the manway entrance. The vapor line was fitted at the manway entrance with a 2-inch-diameter, steel-body angle valve containing a stainless steel ball. Directly under the vapor valve was a 2-inch-diameter excess flow valve. Both cars were equipped with a safety valve and were stenciled to indicate that the valve was set at 247 psi. Both tank cars also were equipped with a sampling line, a gauging device, and a thermometer well at the manway entrance.
